**Flood Control Project Maintenance
Levee Inspections**

Maintenance Issue Types Only, Levee Inspection Report By Mile - Spring 2016

Sutter Maintenance Yard East Levee Sacramento River

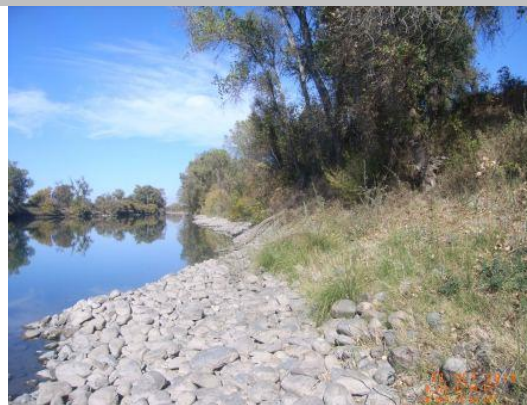
Photo 1 of 1 : SP_2016_ST0003_264_8_20160316_00004.jpg

LM Start	11.53	Rating **	M	Issue No.	8
LM End	11.79	Issue Type +	Ma	Location *	WS
Category	Supplemental			GPS Latitude/Longitude	
				Start	End
Item	2015 USACE Erosion Survey, DRAFT			39.279910 °	39.283853 °
				-122.018221 °	-122.016113 °
DWR ID	DWR_ST0003_01_s_2016_8				
Comment Code					
Inspector Comment					
2008 - Large rotational/mass failure in the bank with tree slump. 2009 - Minimal new erosion, the tree is leaning further into the river. 2011 - Site extended downstream. 2012 - Minor new erosion and tree roots are further exposed. 2015: Last observed in 2013. [2015 Site ID: SAC 152-6 L]

USACE 2013 Photo #1

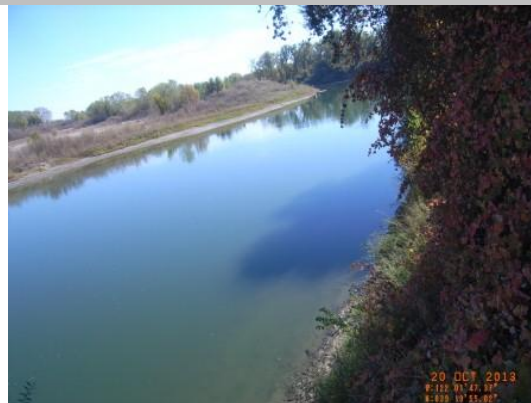
Photo 1 of 1 : SP_2016_ST0003_264_1_20160316_00001.jpg

LM Start	11.85	Rating **	M	Issue No.	1
LM End	11.90	Issue Type +	Ma	Location *	WS
Category	Supplemental			GPS Latitude/Longitude	
				Start	End
Item	2015 USACE Erosion Survey, DRAFT			39.331447 °	39.332716 °
				-122.029440 °	-122.029953 °
DWR ID	DWR_ST0003_01_s_2016_1				
Comment Code					
Inspector Comment					
2004 - Slowly eroding but near vertical with no vegetation to hold it.					
2005 - Erosion is close to levee toe but not into the levee section yet.					
2010 - Some new toe scour. 2015: Last observed in 2013. [2015 Site ID: SAC_157-7_R]

USACE 2013 Photo #1

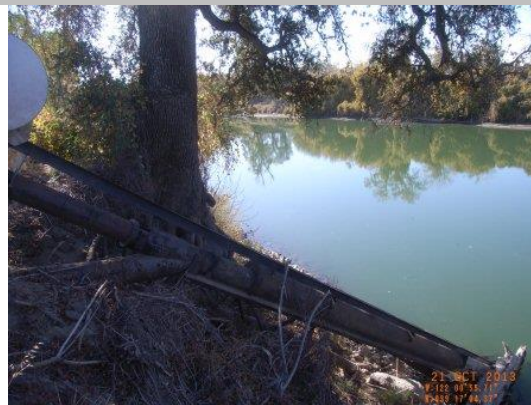
Photo 1 of 1 : SP_2016_ST0003_264_13_20160316_00008.jpg

LM Start	11.85	Rating **	M	Issue No.	13
LM End	11.90	Issue Type +	Ma	Location *	WS
Category	Supplemental			GPS Latitude/Longitude	
				Start	End
Item	2015 USACE Erosion Survey, DRAFT			39.284568 °	39.285298 °
				-122.015690 °	-122.015208 °
DWR ID	DWR_ST0003_01_s_2016_13				
Comment Code					
Inspector Comment					
2006 - Large rotational/mass failure in the bank with tree slump. Tough clayey toe material. 2007 - Site is between stone revetments with a pump station at the downstream end. 2010 - Erosion is into the levee toe. 2011 - Minor new erosion. 2012 - Minor new erosion. 2015: Last observed in 2013. [2015 Site ID: SAC_152-8_L]

USACE 2013 Photo #1

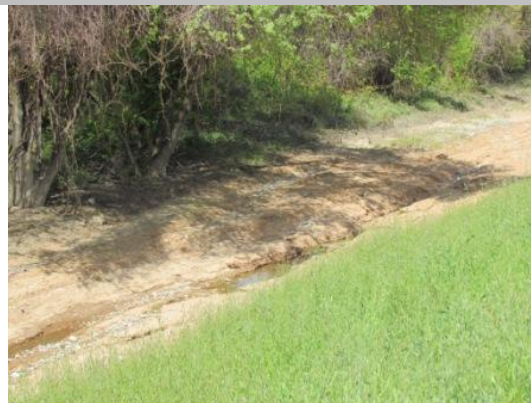
Photo 1 of 1 : SP_2016_ST0003_264_9_20160316_00005.jpg

LM Start	13.47	Rating **	M	Issue No.	9
LM End	13.66	Issue Type +	Ma	Location *	WS
Category	Earthen Levee			GPS Latitude/Longitude	
				Start	End
Item	Erosion / Bank Caving			39.307448 °	39.310231 °
				-122.013037 °	-122.012912 °
DWR ID	DWR_ST0003_01_s_2012_9				
Comment Code					
E1 : Note and monitor erosion site.					
Inspector Comment

View of the erosion along the W/S toe.

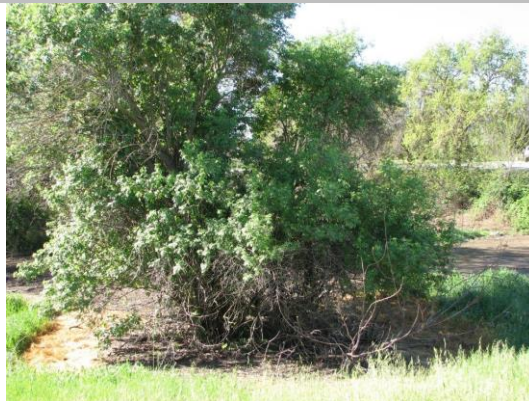
Photo 1 of 1 : SP_2016_ST0003_265_1_20160405_00004.jpg

LM Start	0.02	Rating **	M	Issue No.	1
LM End	0.02	Issue Type +	Ma	Location *	LS
Category	Earthen Levee			GPS Latitude/Longitude	
				Start	End
Item	Vegetation			39.232058 °	39.232058 °
				-121.995514 °	-121.995514 °
DWR ID	DWR_ST0003_02_s_2012_1				
Comment Code					
V4 : Elderberries are blocking visibility and flood fight capability.					
Inspector Comment

Elderberry
